SERVICE BULLETIN

NO. 0045 PAGE 1 OF 1

MW AXLES, DRAG RACE
50100, 50500

AUGUST 28, 1997

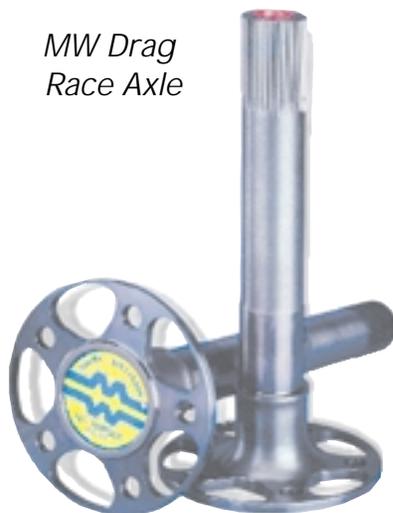
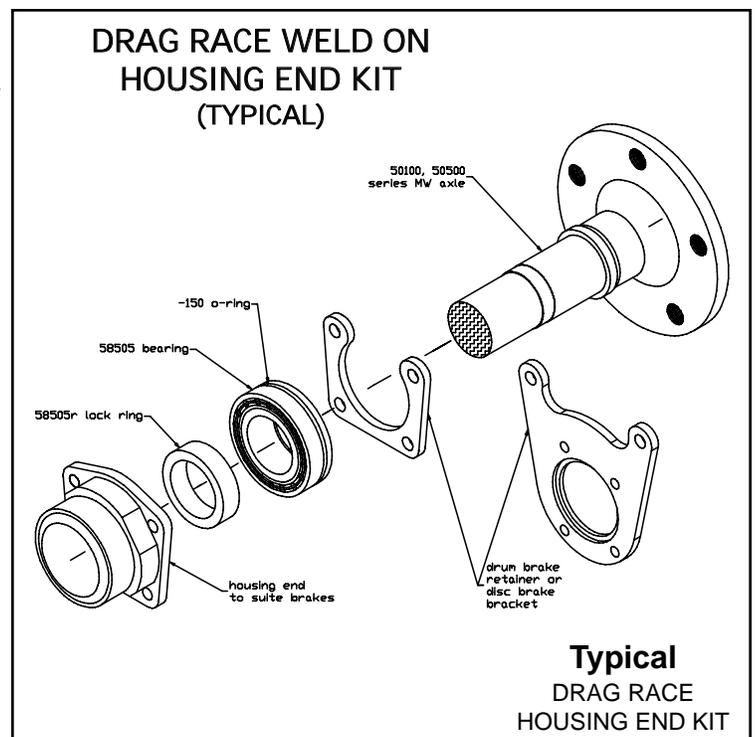
1) NEVER UNDER ANY CONDITION WELD THE BEARING LOCK RING TO THE AXLE. **ANY** WELDING CAUSES CRACKS AND WILL EVENTUALLY CAUSE FAILURE IN THE WELD AREA. MW AXLES ARE MANUFACTURED FROM STEEL THAT CONTAINS .04% CARBON ANY WELDING CAUSES CRACKS (THAT MAY NOT BE VISIBLE TO THE NAKED EYE). WELDING **VOIDS ALL WARRANTIES!** IF YOU HAVE TROUBLE WITH THE WHEEL BEARINGS WORKING OFF THE AXLE, THE PROBABLE CAUSE IS THAT THE HOUSING ENDS ARE NOT ALIGNED PROPERLY.

2) IN ORDER FOR THE 5/8" THREAD DRIVE STUDS TO BE SQUARE IN THE AXLE FLANGE THE STUD MUST SEAT ON THE SHOULDER AND NOT BIND IN THE THREAD WHEN TIGHTENING. IF BINDING IS SUSPECTED CHAMFER THE THREADS IN THE AXLE FLANGE SO THAT IT SEATS SQUARELY. THE 1/2" WHEEL BOLTS MUST USE A WASHER TO PREVENT BINDING IN THE IMPERFECT THREAD END JUST UNDER THE HEAD OF THE BOLT. CLEAN THE PROTECTIVE OIL FROM THE THREADS AND INSTALL THE STUDS OR BOLTS WITH STUD MOUNT # 271 LOCTITE®. A COLLET TYPE DRIVE STUD INSTALLATION TOOL MUST BE USED TO PREVENT DAMAGE TO DRIVE STUDS WHEN INSTALLING.

3) CHECK FOR PROPER SPLINE ENGAGEMENT BEFORE OPERATING THE VEHICLE, THE NORMAL ENGAGEMENT FOR 35 AND 40 SPLINE AXLES IS 1-3/4". THE MINIMUM ENGAGEMENT IS .75 X THE SPLINE DIAMETER.

4) CHECK THE BEARING SECONDARY LOCK RING FOR CLEARANCE INSIDE THE AXLE HOUSING END. A 1/16" GAP IS THE MINIMUM CLEARANCE RECOMMENDED.

5) THE PROPER ALIGNMENT OF THE AXLE HOUSING ENDS IN RELATION TO THE CENTERLINE OF THE THIRDMEMBER MAIN BEARING IS CRITICAL. A BENT HOUSING CONDITION CAN BE DETECTED, IF WHEN INSTALLING THE AXLES IT IS NECESSARY TO FORCE THE AXLE IN ANY DIRECTION TO ALIGN IT WITH THE HOUSING END RECEIVING BORE. THIS IS AN INDICATION THAT THE HOUSING IS BENT OR WAS IMPROPERLY NARROWED. THE REAR HOUSING MISALIGNMENT MUST BE CORRECTED. FAILURE TO CORRECT THE PROBLEM WILL RESULT IN THE WHEEL BEARING WORKING OFF THE AXLE AND/OR BOWING OF THE AXLE SHAFT. THIS IN TURN WILL CAUSE EXCESSIVE RUN OUT OF THE AXLE FLANGE, PREMATURE AXLE TORSIONAL FAILURE AND CONTINUOUS BEARING SEAL LEAKAGE PROBLEMS.
